**Flood Control Project Maintenance  
Levee Inspections**  
**LMA District Cover Sheet**  
**Spring 2017 Levee Inspection Results**

**Tehama County Flood Control and Water Conservation District**

**Spring 2017 Levee Inspection Results**

Waterway			Bank	Unit Miles
Unit No. 01 Deer Creek			Left	4.22
	Spring (March - May)	Summer (June - August)	(September - November) Fall	Winter (December - February)
Unit Maintenance Rating (Fall Only)				
Date of Inspection	4/25/2017 - 4/25/2017			
DWR Inspector	Bob Duffey			
Accompanied By	Ryan Teubert Tehama County

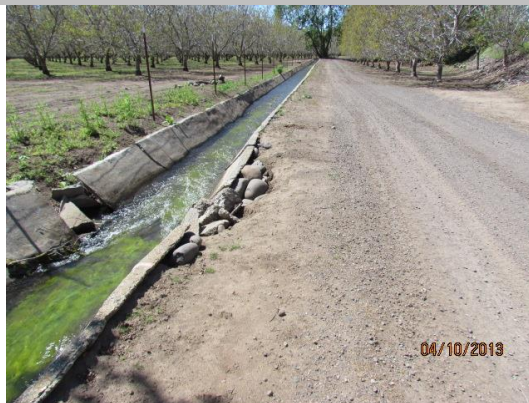
Photo 1 of 1 : SP\_2017\_NA0019\_78\_41\_20170315\_00014.jpg

LM Start	0.00	Rating **	U	Issue No.	41
LM End	0.65	Issue Type +	En	Location *	LS
Category	Earthen Levee			GPS Latitude/Longitude	
				Start	End
Item	Encroachments			39.973077 °	39.971722 °
				-121.980344 °	-121.991869 °
DWR ID	DWR_NA0019_01_s _ 2016_41				
Comment Code					
DT : Ditch					
Inspector Comment					
Concrete-lined ditch on landside.

View of the concrete-lined ditch along landside.

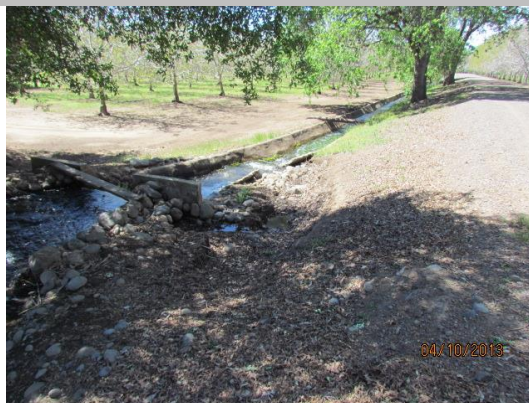
Photo 1 of 1 : SP\_2017\_NA0019\_78\_17\_20170315\_00004.jpg

LM Start	0.01	Rating **	M	Issue No.	17
LM End	0.01	Issue Type +	Ma	Location *	LS
Category	Earthen Levee			GPS Latitude/Longitude	
				Start	End
Item	Erosion / Bank Caving			39.973111 °	39.973111 °
				-121.980466 °	-121.980466 °
DWR ID	DWR_NA0019_01_s _ 2013_17				
Comment Code					
E1 : Note and monitor erosion site.					
Inspector Comment

View of the erosion along the landside slope.

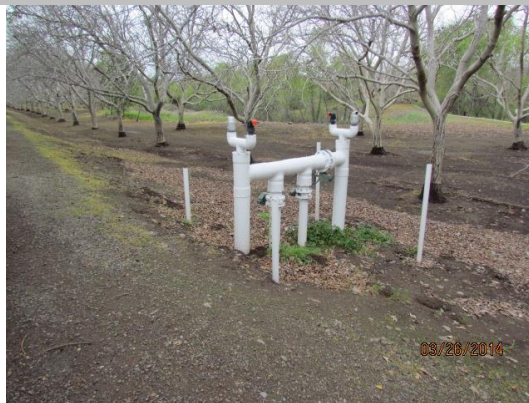
Photo 1 of 1 : SP\_2017\_NA0019\_78\_275\_20170315\_00015.jpg

LM Start	0.02	Rating **	U	Issue No.	275
LM End	0.02	Issue Type +	En	Location *	WS
Category	Earthen Levee			GPS Latitude/Longitude	
				Start	End
Item	Encroachments			39.973128 °	39.973128 °
				-121.980734 °	-121.980734 °
DWR ID	DWR_NA0019_01_s _ 2014_275				
Comment Code					
PI : Pipe					
Inspector Comment

View of the irrigation pipe along the waterside slope.

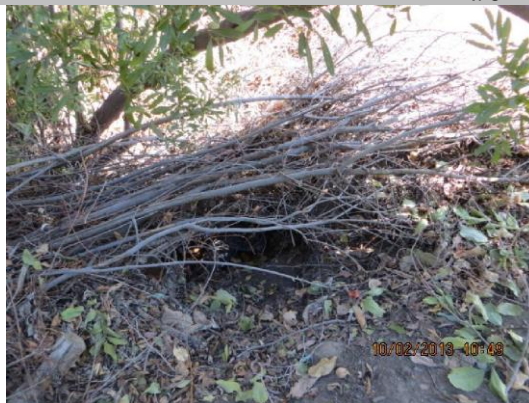
Photo 1 of 2 : UCIP\_SP\_2017\_39840\_39060.jpg

LM Start	0.17	Rating **	M	Issue No.	277
LM End	0.17	Issue Type +	En	Location *	WS
Category	Supplemental			GPS Latitude/Longitude	
				Start	End
Item	DWR UCIP Field Study			39.973302 °	39.973302 °
				-121.983538 °	-121.983538 °
DWR ID					
Comment Code					
Inspector Comment					
FS_ID:39840 DS_ID:24684 EP_NO: N/A Repair Type: Non-Urgent Crossing Status: Found UCIP Comments: No permit identified for this crossing. FIELD_STRUCT_DESC: 36-inch concrete irrigation pipe through the levee 0.5-feet below the crown. Concrete canal and distribution struture on LS shoulder. FS Date: 10/2/2013

Outlet covered by tree trimmings.

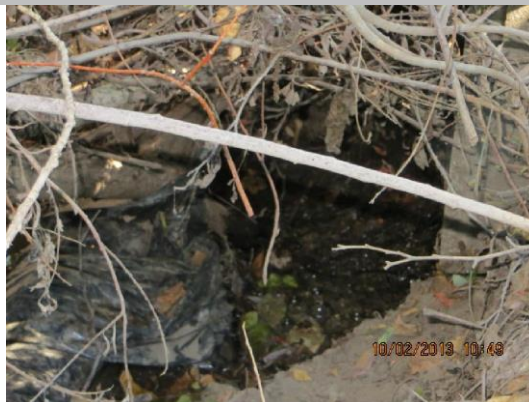
Photo 2 of 2 : UCIP\_SP\_2017\_39840\_39059.jpg

Pipe visible at WS outlet.

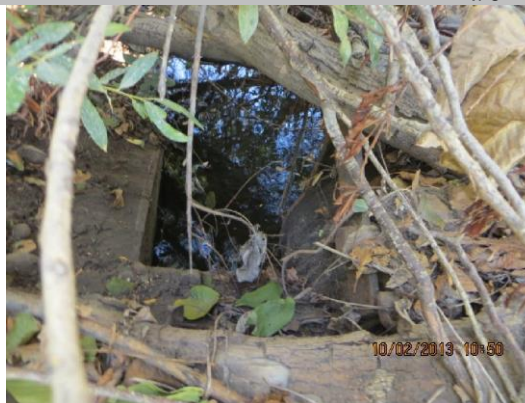
Photo 1 of 1 : UCIP\_SP\_2017\_39838\_39058.jpg

LM Start	0.17	Rating **	M	Issue No.	278
LM End	0.17	Issue Type +	En	Location *	WS
Category	Supplemental			GPS Latitude/Longitude	
				Start	End
Item	DWR UCIP Field Study			39.973285 °	39.973285 °
				-121.983531 °	-121.983531 °
DWR ID					
Comment Code					
Inspector Comment					
FS_ID:39838 DS_ID:24685 EP_NO: N/A Repair Type: Non-Urgent Crossing Status: Found UCIP Comments: No permit identified for this crossing. FIELD_STRUCT_DESC: 24-inch concrete irrigation pipe through the levee 2-feet below the crown. Concrete canal and distribution struture on LS shoulder. Concrete U-shaped headwall and flapgate on WS toe. FS Date: 10/2/2013

Concrete U-shaped headwall and flapgate at WS toe.

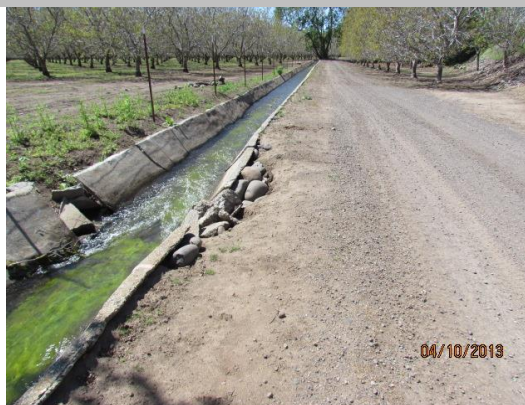
Photo 1 of 1 : SP\_2017\_NA0019\_78\_18\_20170315\_00005.jpg

LM Start	0.41	Rating **	M	Issue No.	18
LM End	0.41	Issue Type +	Ma	Location *	LS
Category	Earthen Levee			GPS Latitude/Longitude	
				Start	End
Item	Erosion / Bank Caving			39.972560 °	39.972560 °
				-121.987759 °	-121.987759 °
DWR ID	DWR_NA0019_01_s_2013_18				
Comment Code					
E1 : Note and monitor erosion site.					
Inspector Comment

View of the erosion along the landside slope.

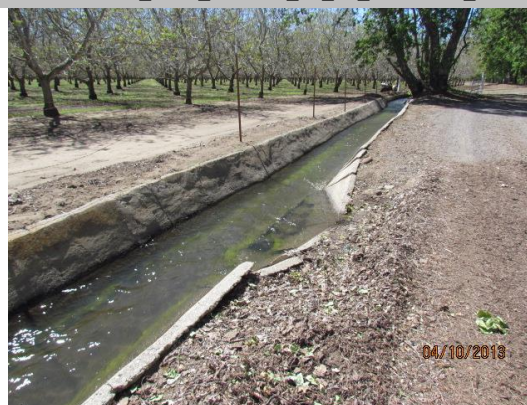
Photo 1 of 1 : SP\_2017\_NA0019\_78\_19\_20170315\_00006.jpg

LM Start	0.46	Rating **	M	Issue No.	19
LM End	0.46	Issue Type +	Ma	Location *	LS
Category	Earthen Levee			GPS Latitude/Longitude	
				Start	End
Item	Erosion / Bank Caving			39.972339 °	39.972339 °
				-121.988763 °	-121.988763 °
DWR ID	DWR_NA0019_01_s_2013_19				
Comment Code					
E1 : Note and monitor erosion site.					
Inspector Comment

View of the erosion along the landside slope.

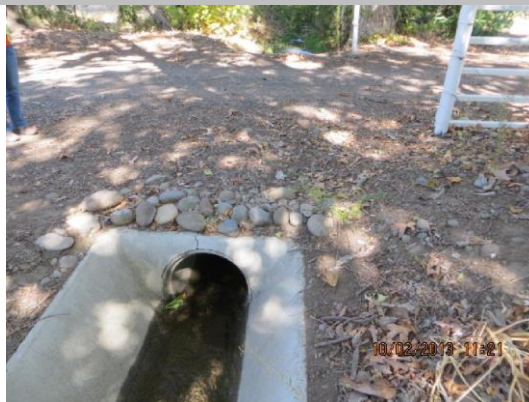
Photo 2 of 3 : UCIP\_SP\_2017\_39839\_39062.jpg

Concrete headwall at canal on LS shoulder.

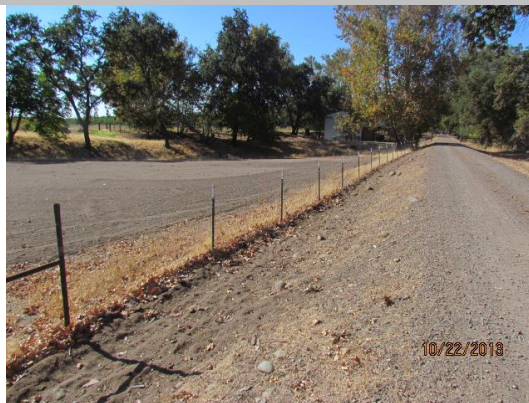
Photo 1 of 1 : SP\_2017\_NA0019\_78\_21\_20170315\_00008.jpg

LM Start	1.52	Rating **	M	Issue No.	21
LM End	1.52	Issue Type +	Ma	Location *	LS
Category	Earthen Levee			GPS Latitude/Longitude	
				Start	End
Item	Animal Control			39.969419 °	39.969419 °
				-122.007850 °	-122.007850 °
DWR ID	DWR_NA0019_01_f_2013_21				
Comment Code					
A2 : Repair the levee slope damaged by livestock and prevent large animal access.					
Inspector Comment

View of the erosion caused by livestock on both slope of the levee.

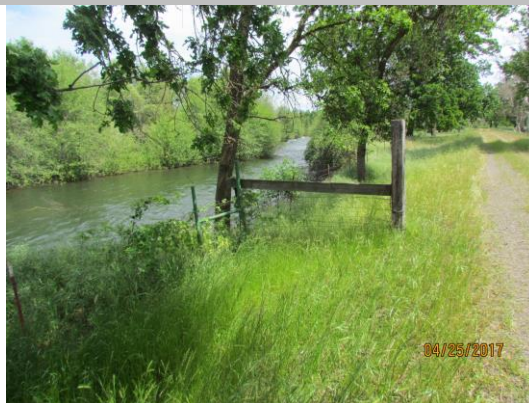
Photo 1 of 1 : SP\_2017\_NA0019\_78\_42\_20170505\_00059.jpg

LM Start	1.55	Rating **	U	Issue No.	42
LM End	1.58	Issue Type +	Ma	Location *	WS
Category	Earthen Levee			GPS Latitude/Longitude	
				Start	End
Item	Erosion / Bank Caving			39.969193 °	39.969052 °
				-122.008458 °	-122.008920 °
DWR ID	DWR_NA0019_01_s_2017_42				
Comment Code					
E2 : Schedule repair of erosion site prior to the next inspection.					
Inspector Comment					
Repair the erosion along the water side toe.

View of the erosion along the waterside toe.

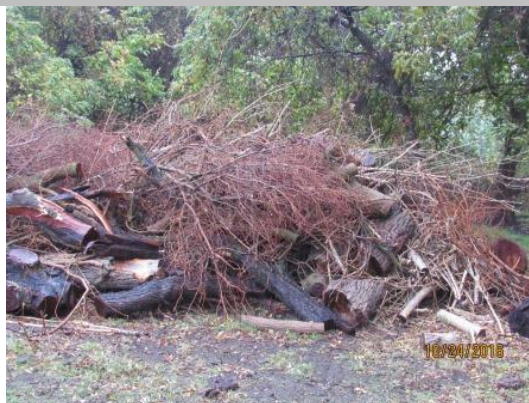
Photo 1 of 1 : SP\_2017\_NA0019\_78\_31\_20170315\_00009.jpg

LM Start	1.66	Rating **	M	Issue No.	31
LM End	1.66	Issue Type +	En	Location *	WS
Category	Earthen Levee			GPS Latitude/Longitude	
				Start	End
Item	Encroachments			39.968670 °	39.968670 °
				-122.010271 °	-122.010271 °
DWR ID	DWR_NA0019_01_f_2016_31				
Comment Code					
PR : Prunings					
Inspector Comment					
Remove prunings from the landside toe.

View of the prunings along the waterside slope.

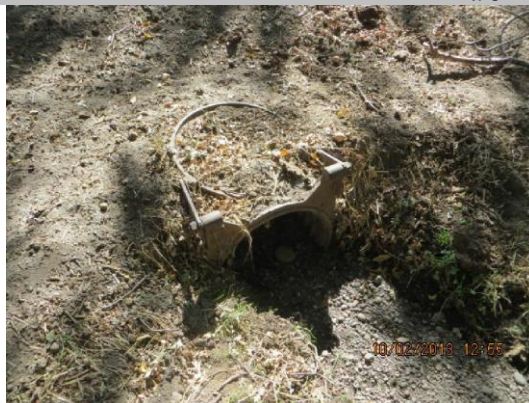
Photo 1 of 3 : UCIP\_SP\_2017\_51437\_36922.jpg

Comment Code					
Inspector Comment					
FS_ID:51437 DS_ID:20770 EP_NO: N/A Repair Type: Non-Urgent Crossing Status: Found UCIP Comments: 12/05/2016 Sediment buildup inside pipe (see photo) and sediment buildup on WS blocking flap gate. Crossing has been downgraded from Urgent to Non-Urgent crossing was closed on both WS and LS. (O. Magana - DWR UCIP)10/02/2013 Flapgate blocked by soil buildup. (W. Wylie - DWR UCIP) FIELD_STRUCT_DESC: 24-inch steel drainage pipe through the levee, 1.5 feet below the crown. Flap gate on the waterside (WS) toe. [Additional Reference(s): DWR Levee Log, 1992. USACE Sacramento O&M Manual Unit 509, March 1957, As-built drawings available 50-4-2394 (Station 185+40)]. FS Date: 12/5/2016

Flapgate on WS toe.

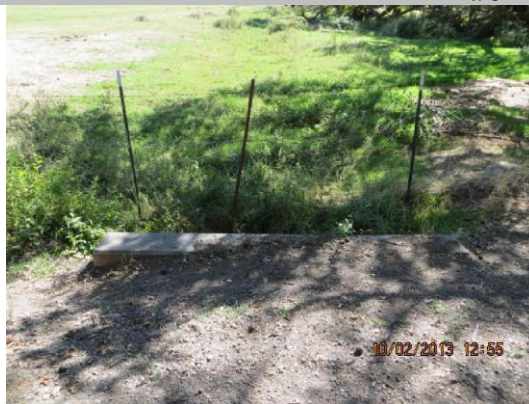
Photo 2 of 3 : UCIP\_SP\_2017\_51437\_36921.jpg

Concrete headwall on LS toe.

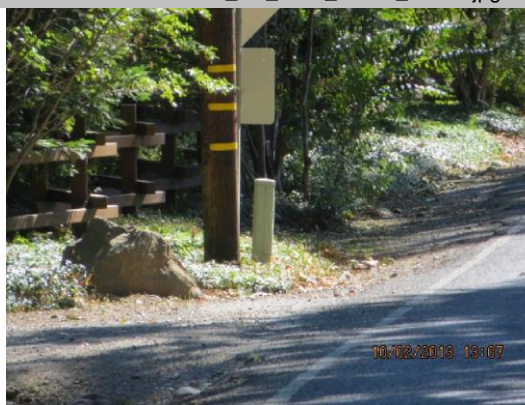
Photo 1 of 3 : UCIP\_SP\_2017\_39837\_39067.jpg

LM Start	1.88	Rating **	M	Issue No.	281
LM End	1.88	Issue Type +	En	Location *	LS
Category	Supplemental			GPS Latitude/Longitude	
				Start	End
Item	DWR UCIP Field Study			39.969156 °	39.969156 °
				-122.013809 °	-122.013809 °
DWR ID					
Comment Code					
Inspector Comment					
FS_ID:39837 DS_ID:24690 EP_NO: N/A Repair Type: Non-Urgent Crossing Status: Found UCIP Comments: No permit identified for this crossing. FIELD_STRUCT_DESC: 4-inch steel conduit through the levee at an unknown depth. Junction box off LS toe next to JP and roadway. Conduit visible on upstream side of bridge at Deer Creek crossing. FS Date: 10/2/2013

Communication box off LS shoulder next to roadway.

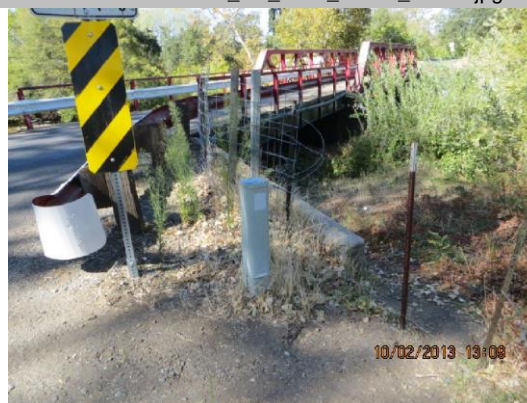
Photo 2 of 3 : UCIP\_SP\_2017\_39837\_39066.jpg

LM Start	1.88	Rating **	M	Issue No.	281 (cont)
LM End	1.88	Issue Type +	En	Location *	LS
Category	Supplemental			GPS Latitude/Longitude	
				Start	End
Item	DWR UCIP Field Study			39.969156°	39.969156°
				-122.013809°	-122.013809°
DWR ID					
Comment Code					
Inspector Comment					
FS_ID:39837 DS_ID:24690 EP_NO: N/A Repair Type: Non-Urgent Crossing Status: Found UCIP Comments: No permit identified for this crossing. FIELD_STRUCT_DESC: 4-inch steel conduit through the levee at an unknown depth. Junction box off LS toe next to JP and roadway. Conduit visible on upstream side of bridge at Deer Creek crossing. FS Date: 10/2/2013

Communication box on WS shoulder.

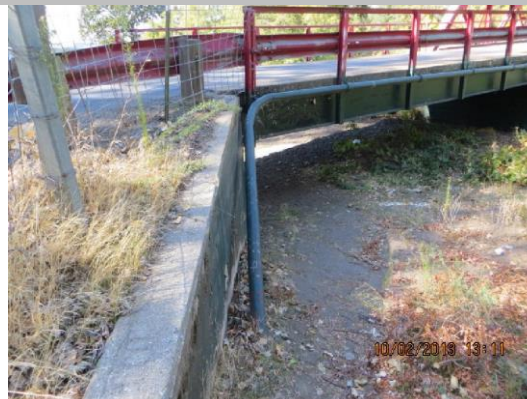
Photo 3 of 3 : UCIP\_SP\_2017\_39837\_39065.jpg

Conduit visible on WS slope and at upstream side of bridge.

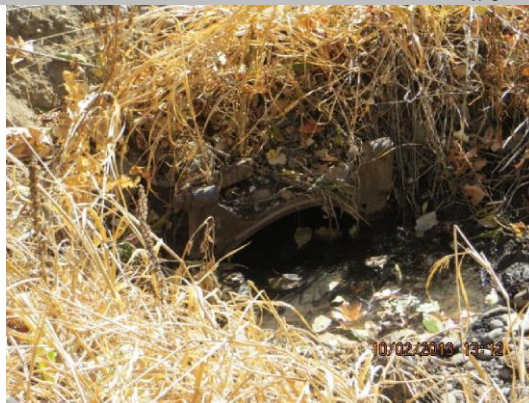
Photo 1 of 3 : UCIP\_SP\_2017\_51438\_36925.jpg

FS\_ID:51438  
 DS\_ID:20769  
 EP\_NO: N/A  
 Repair Type: Urgent  
 Crossing Status: Found  
 UCIP Comments: 12/05/2016 same as last inspection. Crossing remains "Urgent" WS opened during flood season due to damaged flap gate. (O. Magana - DWR UCIP)10/02/2013 Flapgate missing or burried on WS toe. Pipe partially blocked by soil on WS toe. (W. Wylie - DWR UCIP)  
 FIELD\_STRUCT\_DESC: 24-inch corrugated metal drainage pipe through the levee, 7 feet below the crown. Flap gate located on the waterside (WS) end. A 5-foot by 5-foot concrete control structure located on the landside (LS) toe. [Additional Reference(s): DWR Levee Log, 1992. USACE Sacramento O&M Manual Unit 509, March 1957, As-built drawing no. 50-4-2394 (Station 176+10)].  
 FS Date: 12/5/2016

Pipe on WS toe with flapgate hinges.

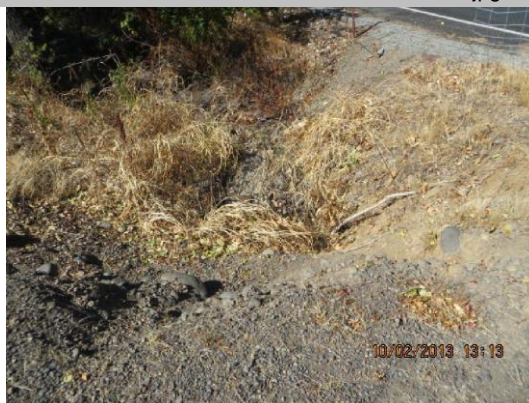
Photo 2 of 3 : UCIP\_SP\_2017\_51438\_36924.jpg

Outlet on WS toe.

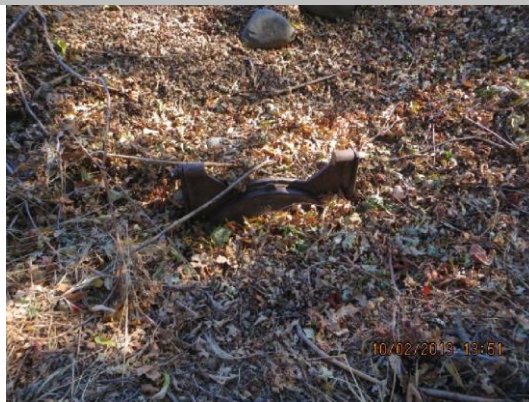
Photo 2 of 2 : UCIP\_SP\_2017\_22824\_38945.jpg

LM Start	2.86	Rating **	M	Issue No.	284
LM End	2.86	Issue Type +	Ma	Location *	WS
Category	Supplemental			GPS Latitude/Longitude	
				Start	End
Item	DWR UCIP LMA Responsibility			39.963938 °	39.963938 °
				-122.030128 °	-122.030128 °
DWR ID					
Comment Code					
Inspector Comment					
FS_ID:22824 DS_ID:20767 EP_NO: N/A Repair Type: Non-Urgent Crossing Status: Found UCIP Comments: Pipe blocked by soil. FIELD_STRUCT_DESC: 24-inch pipe through the levee 6-feet below the crown. Flap gate on the waterward end. Originally included in O+M manual (1957). As-built drawings available 50-4-2394. FS Date: 10/2/2013

Flapgate blocked by soil and debris.

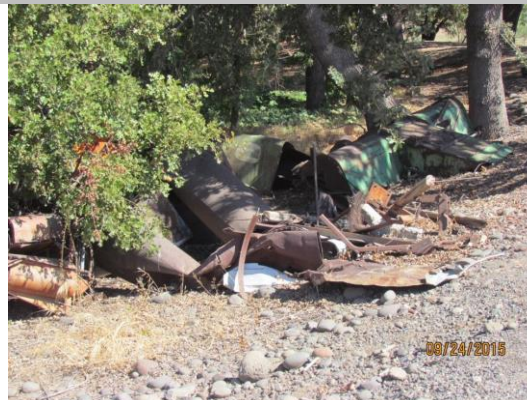
Photo 1 of 1 : SP\_2017\_NA0019\_78\_37\_20170315\_00011.jpg

LM Start	3.06	Rating **	M	Issue No.	37
LM End	3.06	Issue Type +	En	Location *	WS
Category	Earthen Levee			GPS Latitude/Longitude	
				Start	End
Item	Encroachments			39.961798 °	39.961798 °
				-122.032723 °	-122.032723 °
DWR ID	DWR_NA0019_01_f_2015_37				
Comment Code					
EQ : Equipment					
Inspector Comment					
Remove the scrap equipment along the waterside toe.

View of the scrap equipment along the waterside toe.

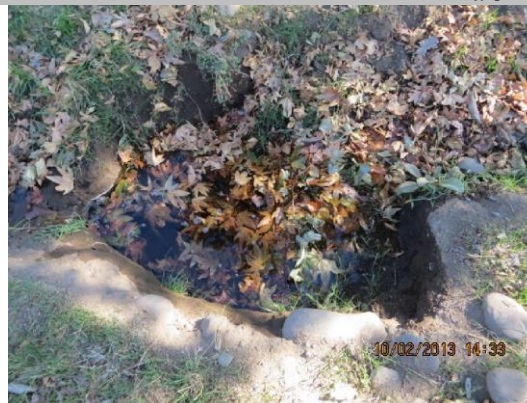
Photo 2 of 3 : UCIP\_SP\_2017\_22825\_38951.jpg

LM Start	3.29	Rating **	M	Issue No.	285 (cont)	
LM End	3.29	Issue Type +	En	Location *	LS	
Category	Supplemental			GPS Latitude/Longitude		
				Start	End	
Item	DWR UCIP Field Study			39.947484 °	39.947484 °	
				-122.049011 °	-122.049011 °	
DWR ID						
Comment Code						
Inspector Comment						
FS_ID:22825						
DS_ID:20766						
EP_NO: N/A						
Repair Type: Non-Urgent						
Crossing Status: Indicator Found						
UCIP Comments: Pipe buried. Water flows to low spot and dissapears, but pipe not visible.						
FIELD_STRUCT_DESC: 24-inch pipe through the levee 8-feet below the crown, flap gate on waterward end. Originally included in O+M manual (1957). As-built drawing No. 50-4-2394.						
FS Date: 10/2/2013

Low spot with water on LS toe.

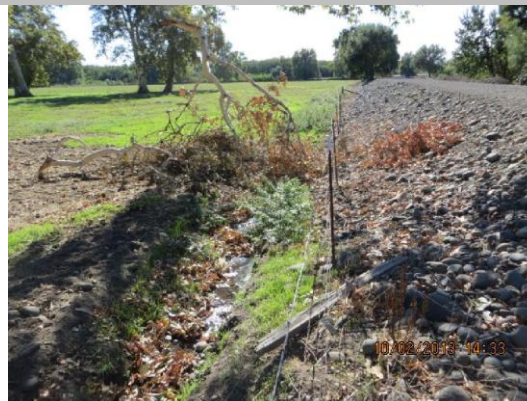
Photo 3 of 3 : UCIP\_SP\_2017\_22825\_38953.jpg

Low spot on LS toe where water dissapears from levee toe. Unable to identify exact location of pipe on LS toe.

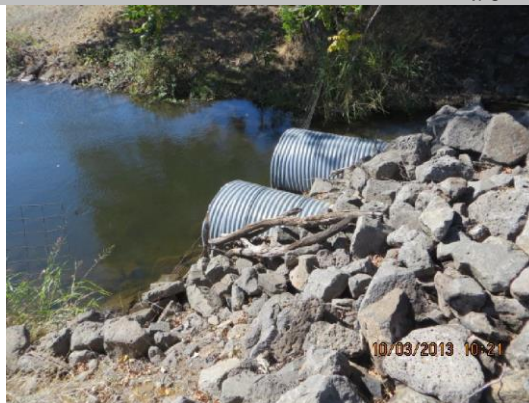
Photo 1 of 3 : UCIP\_SP\_2017\_23007\_39070.jpg

LM Start	3.59	Rating **	M	Issue No.	286
LM End	3.59	Issue Type +	En	Location *	LS
Category	Supplemental			GPS Latitude/Longitude	
				Start	End
Item	DWR UCIP Field Study			39.945964 °	39.945964 °
				-122.054229 °	-122.054229 °
DWR ID					
Comment Code					
Inspector Comment					
FS_ID:23007 DS_ID:24687 EP_NO: N/A Repair Type: Non-Urgent Crossing Status: Found UCIP Comments: No permit identified for this crossing. FIELD_STRUCT_DESC: 48-inch corrugated metal drainpipe through the levee, 6-feet below the crown. Flap gate on the waterward end. FS Date: 10/3/2013

Pipe visible on LS toe.

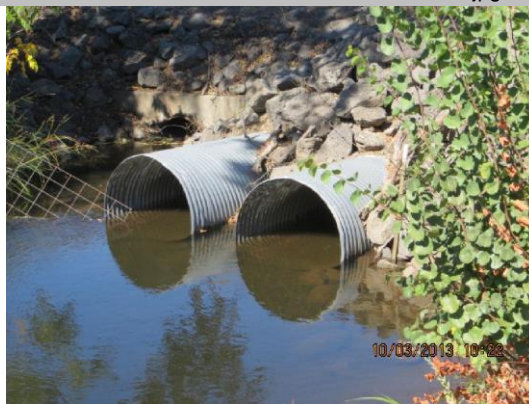
Photo 2 of 3 : UCIP\_SP\_2017\_23007\_39069.jpg

Pipe visible on LS toe.

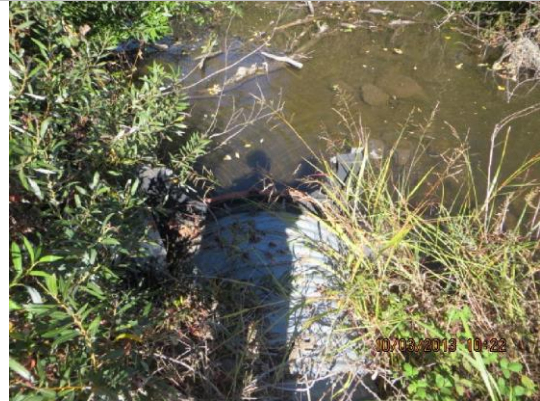
Photo 3 of 3 : UCIP\_SP\_2017\_23007\_39068.jpg

LM Start	3.59	Rating **	M	Issue No.	286 (cont)	
LM End	3.59	Issue Type +	En	Location *	LS	
Category	Supplemental			GPS Latitude/Longitude		
				Start	End	
Item	DWR UCIP Field Study			39.945964 °	39.945964 °	
				-122.054229 °	-122.054229 °	
DWR ID						
Comment Code						
Inspector Comment						
FS_ID:23007						
DS_ID:24687						
EP_NO: N/A						
Repair Type: Non-Urgent						
Crossing Status: Found						
UCIP Comments: No permit identified for this crossing.						
FIELD_STRUCT_DESC: 48-inch corrugated metal drainpipe through the levee, 6-feet below the crown. Flap gate on the waterward end.						
FS Date: 10/3/2013

Flapgate visible on WS toe.

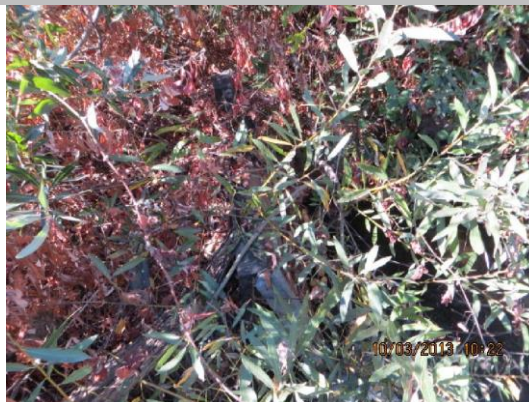
Photo 3 of 3 : UCIP\_SP\_2017\_39836\_39071.jpg

LM Start	3.60	Rating **	M	Issue No.	287 (cont)	
LM End	3.60	Issue Type +	En	Location *	LS	
Category	Supplemental			GPS Latitude/Longitude		
				Start		End
Item	DWR UCIP Field Study			39.945952 °		39.945952 °
				-122.054259 °		-122.054259 °
DWR ID						
Comment Code						
Inspector Comment						
FS_ID:39836						
DS_ID:24688						
EP_NO: N/A						
Repair Type: Non-Urgent						
Crossing Status: Found						
UCIP Comments: No permit identified for this crossing. Brush should be removed from flapgate outlet.						
FIELD_STRUCT_DESC: 48-inch corrugated metal drainpipe through the levee, 6-feet below the crown. Flap gate on the waterward end.						
FS Date: 10/3/2013

Flapgate visible on WS toe covered in brush.

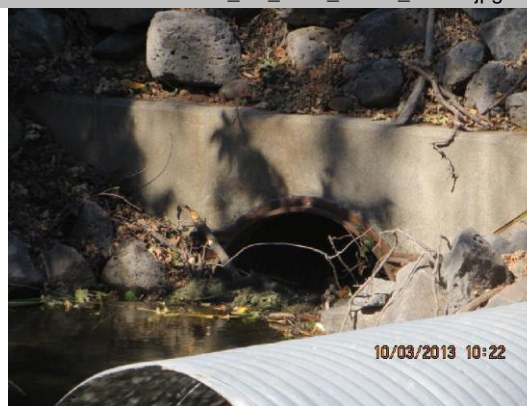
Photo 1 of 3 : UCIP\_SP\_2017\_51439\_39076.jpg

Comment Code					
Inspector Comment					
FS_ID:51439 DS_ID:24689 EP_NO: N/A Repair Type: Non-Urgent Crossing Status: Found UCIP Comments: 12/05/2016 same as last inspection. Crossing has been downgraded from Urgent to Non-Urgent WS flap gate is closed. Recommend clearing dense vegetation on WS and completing an internal inspection to determine condition of the pipe through the levee. (O. Magana - DWR UCIP)10/03/2013 Flapgate does not fully close. Needs brush cleared away from outlet. (W. Wylie - DWR UCIP) FIELD_STRUCT_DESC: 36-inch corrugated metal drainage pipe through the levee, 7 feet below the crown. Flap gate located on the waterside (WS) end. Concrete headwall located on the landside (LS) toe. FS Date: 12/5/2016

Pipe visible at headwall on LS toe.

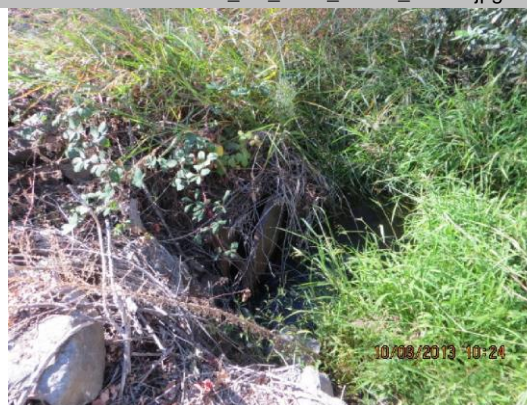
Photo 2 of 3 : UCIP\_SP\_2017\_51439\_39075.jpg

Flapgate visible on WS toe.

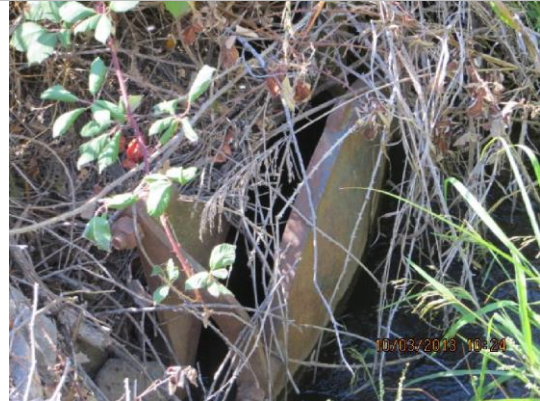
Photo 3 of 3 : UCIP\_SP\_2017\_51439\_39074.jpg

Item	DWR UCIP Field Study			39.945928 °	39.945928 °	
				-122.054305 °	-122.054305 °	
DWR ID						
Comment Code						
Inspector Comment						
FS_ID:51439						
DS_ID:24689						
EP_NO: N/A						
Repair Type: Non-Urgent						
Crossing Status: Found						
UCIP Comments: 12/05/2016 same as last inspection. Crossing has been downgraded from Urgent to Non-Urgent WS flap gate is closed. Recommend clearing dense vegetation on WS and completing an internal inspection to determine condition of the pipe through the levee. (O. Magana - DWR UCIP)10/03/2013 Flapgate does not fully close. Needs brush cleared away from outlet. (W. Wylie - DWR UCIP)						
FIELD_STRUCT_DESC: 36-inch corrugated metal drainage pipe through the levee, 7 feet below the crown. Flap gate located on the waterside (WS) end. Concrete headwall located on the landside (LS) toe.						
FS Date: 12/5/2016

Flapgate visible on WS toe.

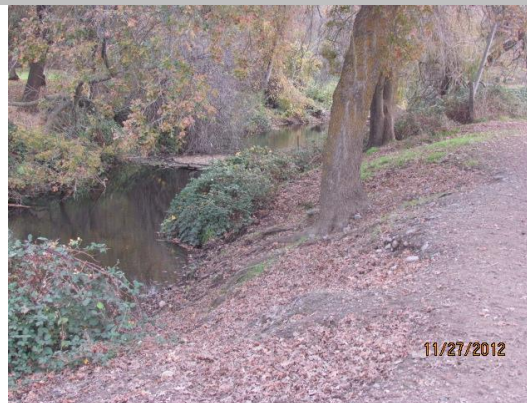
Photo 1 of 1 : SP\_2017\_NA0019\_78\_15\_20170315\_00002.jpg

LM Start	3.68	Rating **	M	Issue No.	15
LM End	3.68	Issue Type +	Ma	Location *	LS
Category	Earthen Levee			GPS Latitude/Longitude	
				Start	End
Item	Slope Stability			39.945045 °	39.945045 °
				-122.053469 °	-122.053469 °
DWR ID	DWR_NA0019_01_f_2012_15				
Comment Code					
S1 : Repair slope instability.					
Inspector Comment

View of the erosion caused by livestock along the landside slope.

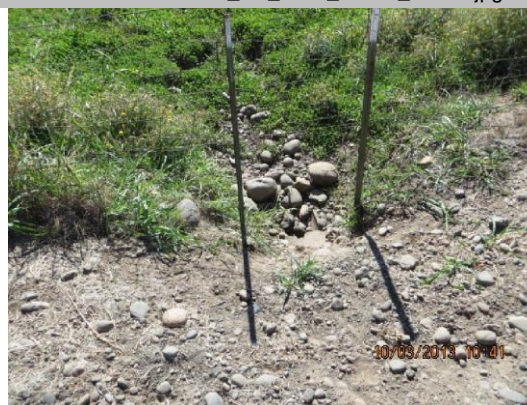
Photo 1 of 3 : UCIP\_SP\_2017\_23094\_39307.jpg

LM Start	3.75	Rating **	M	Issue No.	289	
LM End	3.75	Issue Type +	En	Location *	LS	
Category	Supplemental			GPS Latitude/Longitude		
				Start	End	
Item	DWR UCIP Field Study			39.944460 °	39.944460 °	
				-122.053930 °	-122.053930 °	
DWR ID						
Comment Code						
Inspector Comment						
FS_ID:23094 DS_ID:20763 EP_NO: N/A Repair Type: Non-Urgent Crossing Status: Found UCIP Comments: Erosion on WS toe. FIELD_STRUCT_DESC: 12-inch concrete stormdrain pipe, through the levee, 2-feet below the crown. FS Date: 10/3/2013

Concrete pipe at inlet on LS toe.

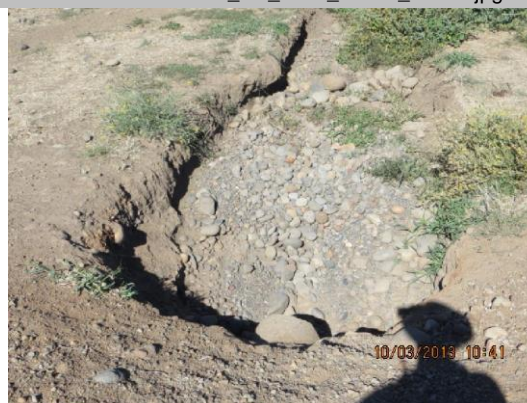
Photo 2 of 3 : UCIP\_SP\_2017\_23094\_39306.jpg

LM Start	3.75	Rating **	M	Issue No.	289 (cont)	
LM End	3.75	Issue Type +	En	Location *	LS	
Category	Supplemental			GPS Latitude/Longitude		
				Start	End	
Item	DWR UCIP Field Study			39.944460 °	39.944460 °	
				-122.053930 °	-122.053930 °	
DWR ID						
Comment Code						
Inspector Comment						
FS_ID:23094						
DS_ID:20763						
EP_NO: N/A						
Repair Type: Non-Urgent						
Crossing Status: Found						
UCIP Comments: Erosion on WS toe.						
FIELD_STRUCT_DESC: 12-inch concrete stormdrain pipe, through the						
levee, 2-feet below the crown.						
FS Date: 10/3/2013

Concrete pipe at outlet on WS toe.

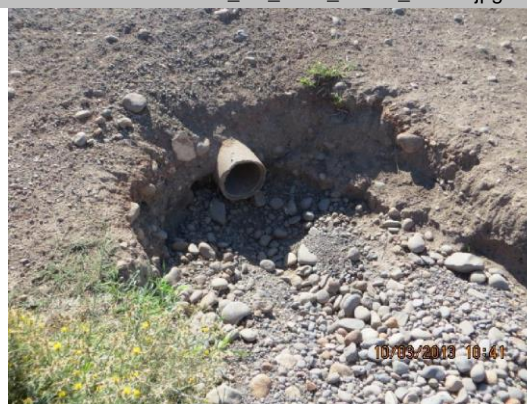
Photo 3 of 3 : UCIP\_SP\_2017\_23094\_39305.jpg

Concrete pipe at outlet on WS toe.

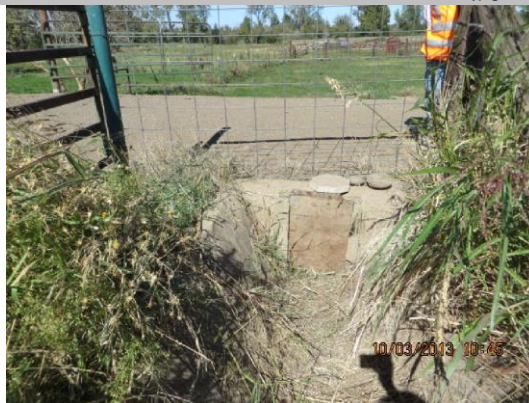
Photo 1 of 3 : UCIP\_SP\_2017\_23092\_39298.jpg

LM Start	3.75	Rating **	M	Issue No.	290
LM End	3.75	Issue Type +	En	Location *	LS
Category	Supplemental			GPS Latitude/Longitude	
				Start	End
Item	DWR UCIP Field Study			39.944426 °	39.944426 °
				-122.054045 °	-122.054045 °
DWR ID					
Comment Code					
Inspector Comment					
FS_ID:23092					
DS_ID:24691					
EP_NO: N/A					
Repair Type: Non-Urgent					
Crossing Status: Found					
UCIP Comments: Outlet substantially blocked at WS toe. No permit identified for this crossing.					
FIELD_STRUCT_DESC: 10-inch concrete irrigation pipe through the levee 2.0-feet below the crown. Slide gate at terminal end of concrete channel on LS shoulder.					
FS Date: 10/3/2013

Slide panel at inlet on LS shoulder.

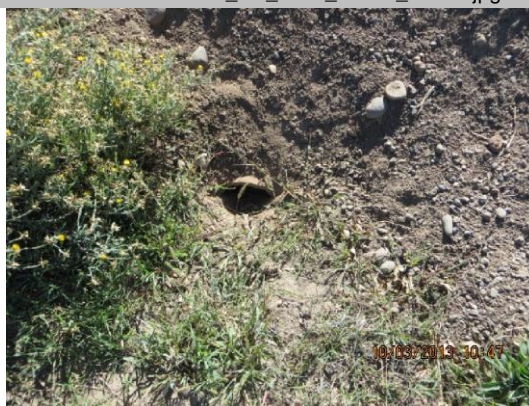
Photo 3 of 3 : UCIP\_SP\_2017\_23092\_39296.jpg

LM Start	3.75	Rating **	M	Issue No.	290 (cont)	
LM End	3.75	Issue Type +	En	Location *	LS	
Category	Supplemental			GPS Latitude/Longitude		
				Start	End	
Item	DWR UCIP Field Study			39.944426 °	39.944426 °	
				-122.054045 °	-122.054045 °	
DWR ID						
Comment Code						
Inspector Comment						
FS_ID:23092						
DS_ID:24691						
EP_NO: N/A						
Repair Type: Non-Urgent						
Crossing Status: Found						
UCIP Comments: Outlet substantially blocked at WS toe. No permit identified for this crossing.						
FIELD_STRUCT_DESC: 10-inch concrete irrigation pipe through the levee 2.0-feet below the crown. Slide gate at terminal end of concrete channel on LS shoulder.						
FS Date: 10/3/2013

Pipe outlet on WS toe.

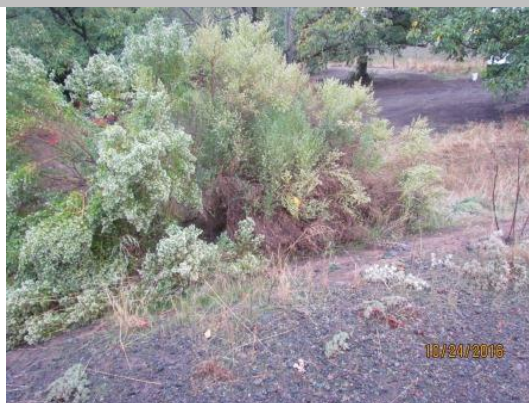
Photo 1 of 1 : SP\_2017\_NA0019\_78\_16\_20170315\_00003.jpg

LM Start	3.75	Rating **	M	Issue No.	16
LM End	3.75	Issue Type +	Ma	Location *	LS
Category	Earthen Levee			GPS Latitude/Longitude	
				Start	End
Item	Vegetation			39.944407 °	39.944407 °
				-122.054104 °	-122.054104 °
DWR ID	DWR_NA0019_01_f_2016_16				
Comment Code					
V2 : Remove the wild growth other than native grasses from the levee slopes.					
Inspector Comment

View of a bush obstructing visibility.

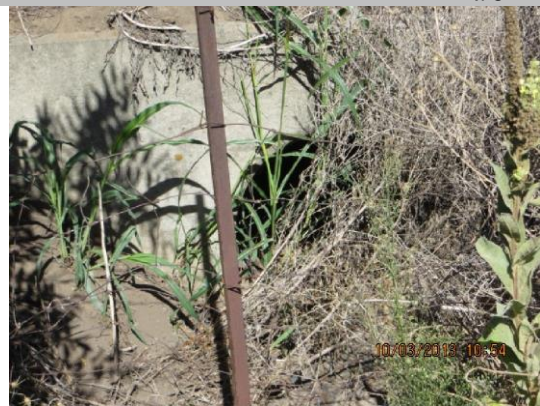
Photo 1 of 3 : UCIP\_SP\_2017\_21741\_36937.jpg

LM Start	4.03	Rating **	A/W	Issue No.	291
LM End	4.03	Issue Type +	Ma	Location *	WS
Category	Supplemental			GPS Latitude/Longitude	
				Start	End
Item	DWR UCIP LMA Responsibility			39.941574 °	39.941574 °
				-122.057597 °	-122.057597 °
DWR ID					
Comment Code					
Inspector Comment					
FS_ID:21741					
DS_ID:20760					
EP_NO: N/A					
Repair Type: No Action Needed					
Crossing Status: Found					
UCIP Comments:					
FIELD_STRUCT_DESC: 24-inch corrugated metal stormdrain pipe through the levee, 5-feet below the crown. Flap gate on the waterward end. Headwalls on both sides of levee. Originally included in O+M manual (1957). As-built drawing No. 50-4-2394.					
FS Date: 10/3/2013

Pipe and concrete headwall on LS toe.

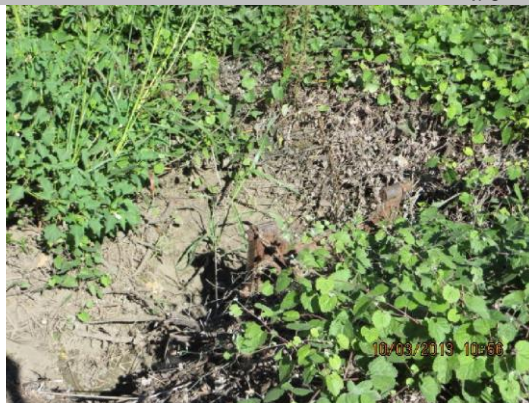
Photo 2 of 3 : UCIP\_SP\_2017\_21741\_36936.jpg

LM Start	4.03	Rating **	A/W	Issue No.	291 (cont)
LM End	4.03	Issue Type +	Ma	Location *	WS
Category	Supplemental			GPS Latitude/Longitude	
				Start	End
Item	DWR UCIP LMA Responsibility			39.941574 °	39.941574 °
				-122.057597 °	-122.057597 °
DWR ID					
Comment Code					
Inspector Comment					
FS_ID:21741					
DS_ID:20760					
EP_NO: N/A					
Repair Type: No Action Needed					
Crossing Status: Found					
UCIP Comments:					
FIELD_STRUCT_DESC: 24-inch corrugated metal stormdrain pipe through the levee, 5-feet below the crown. Flap gate on the waterward end. Headwalls on both sides of levee. Originally included in O+M manual (1957). As-built drawing No. 50-4-2394.					
FS Date: 10/3/2013

Flapgate on WS toe.

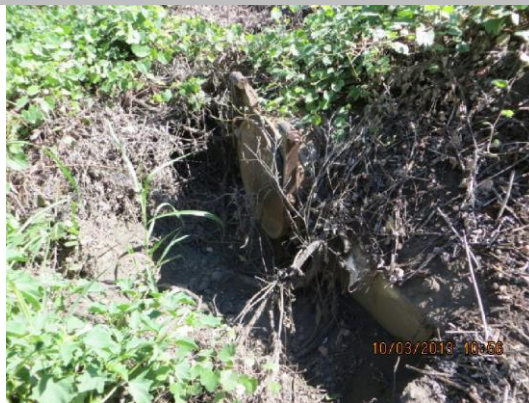
Photo 3 of 3 : UCIP\_SP\_2017\_21741\_36935.jpg

Flapgate and concrete headwall on WS toe.

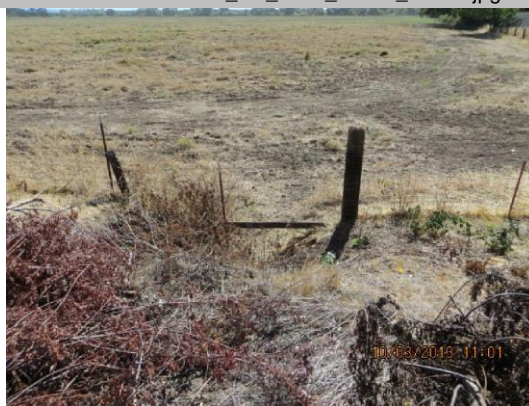
Photo 1 of 3 : UCIP\_SP\_2017\_51441\_36942.jpg

LM Start	4.10	Rating **	U	Issue No.	292
LM End	4.10	Issue Type +	Ma	Location *	WS
Category	Supplemental			GPS Latitude/Longitude	
				Start	End
Item	DWR UCIP LMA Responsibility			39.941002 °	39.941002 °
				-122.058711 °	-122.058711 °
DWR ID					
Comment Code					
Inspector Comment					
FS_ID:51441 DS_ID:20762 EP_NO: N/A Repair Type: Urgent Crossing Status: Found UCIP Comments: 12/05/2016 unable to complete inspection -- unable to locate. (O. Magana - DWR UCIP)10/03/2013 Gate missing from WS toe. (W. Wylie - DWR UCIP) FIELD_STRUCT_DESC: 24-inch corrugated metal drainage pipe through the levee, 5.5 feet below the crown. Flap gate located on the waterside (WS) end. Concrete headwall located on the landside (LS) toe. [Additional Reference(s): DWR Levee Log, 1992. USACE Sacramento O&M Manual Unit 509, March 1957, As-built drawing no. 50-4-2394 (Station 0+65)]. FS Date: 12/5/2016

Inlet on LS toe.

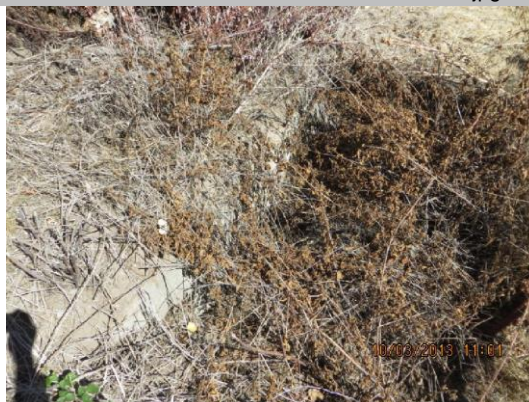
Photo 2 of 3 : UCIP\_SP\_2017\_51441\_36941.jpg

Concrete headwall at inlet on LS toe.

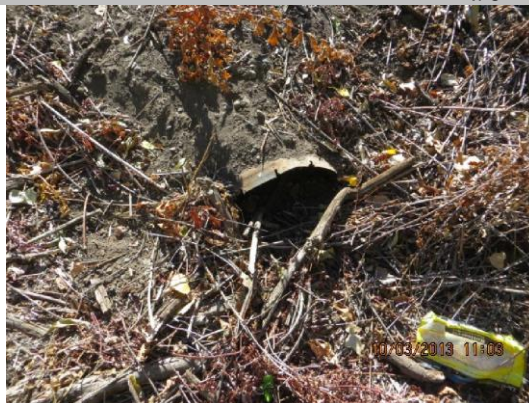
Photo 3 of 3 : UCIP\_SP\_2017\_51441\_36940.jpg

Item	DWR UCIP LMA Responsibility			39.941002 °	39.941002 °	
				-122.058711 °	-122.058711 °	
DWR ID						
Comment Code						
Inspector Comment						
FS_ID:51441 DS_ID:20762 EP_NO: N/A Repair Type: Urgent Crossing Status: Found UCIP Comments: 12/05/2016 unable to complete inspection -- unable to locate. (O. Magana - DWR UCIP)10/03/2013 Gate missing from WS toe. (W. Wylie - DWR UCIP) FIELD_STRUCT_DESC: 24-inch corrugated metal drainage pipe through the levee, 5.5 feet below the crown. Flap gate located on the waterside (WS) end. Concrete headwall located on the landside (LS) toe. [Additional Reference(s): DWR Levee Log, 1992. USACE Sacramento O&M Manual Unit 509, March 1957, As-built drawing no. 50-4-2394 (Station 0+65)]. FS Date: 12/5/2016

Flap gate missing from pipe at WS toe.

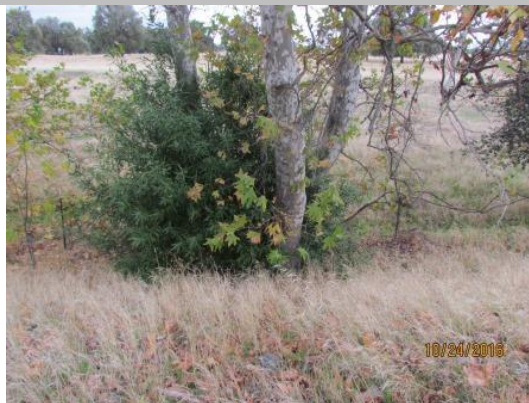
Photo 1 of 1 : SP\_2017\_NA0019\_79\_13\_20170315\_00007.jpg

LM Start	0.23	Rating **	M	Issue No.	13
LM End	0.23	Issue Type +	Ma	Location *	LS
Category	Earthen Levee			GPS Latitude/Longitude	
				Start	End
Item	Trim / Thin Trees			39.970598 °	39.970598 °
				-122.013053 °	-122.013053 °
DWR ID	DWR_NA0019_02_f_2016_13				
Comment Code					
T1 : Trim trees to at least five feet above ground level.					
Inspector Comment

View of a tree with new thick growth blocking visibility.

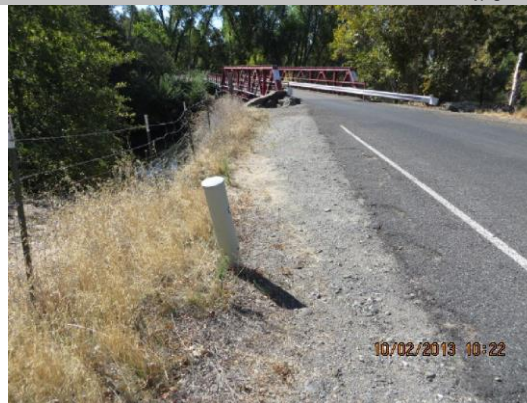
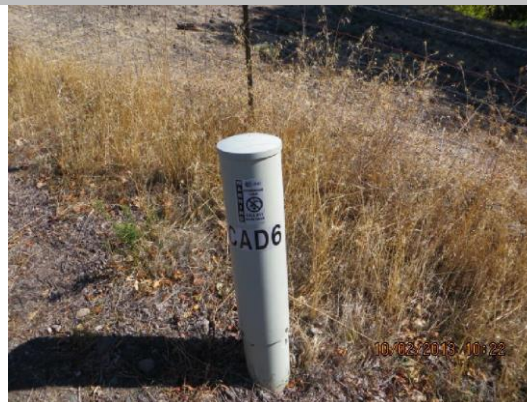
LM Start	0.31	Rating **	M	Issue No.	19
LM End	0.31	Issue Type +	En	Location *	LS
Category	Supplemental			GPS Latitude/Longitude	
				Start	End
Item	DWR UCIP Field Study			39.970256 °	39.970256 °
				-122.014471 °	-122.014471 °
DWR ID					
Comment Code					
Inspector Comment					
FS_ID:40789 DS_ID:24683 EP_NO: N/A Repair Type: Non-Urgent Crossing Status: Found UCIP Comments: No permit identified for this crossing. FIELD_STRUCT_DESC: 4-inch galvanized iron communication conduit through the levee at an unknown depth. Pipe visible on upstream side of bridge. FS Date: 10/2/2013

Communication line access box on WS shoulder.

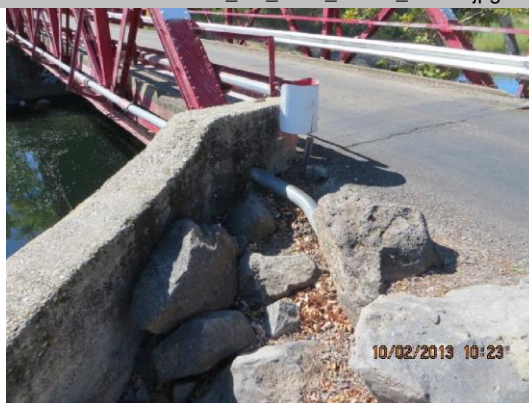
Photo 3 of 3 : UCIP\_SP\_2017\_40789\_39055.jpg

LM Start	0.31	Rating **	M	Issue No.	19 (cont)
LM End	0.31	Issue Type +	En	Location *	LS
Category	Supplemental			GPS Latitude/Longitude	
				Start	End
Item	DWR UCIP Field Study			39.970256 °	39.970256 °
				-122.014471 °	-122.014471 °
DWR ID					
Comment Code					
Inspector Comment					
FS_ID:40789 DS_ID:24683 EP_NO: N/A Repair Type: Non-Urgent Crossing Status: Found UCIP Comments: No permit identified for this crossing. FIELD_STRUCT_DESC: 4-inch galvanized iron communication conduit through the levee at an unknown depth. Pipe visible on upstream side of bridge. FS Date: 10/2/2013

Communication line conduit visible on upstream side of bridge at WS.

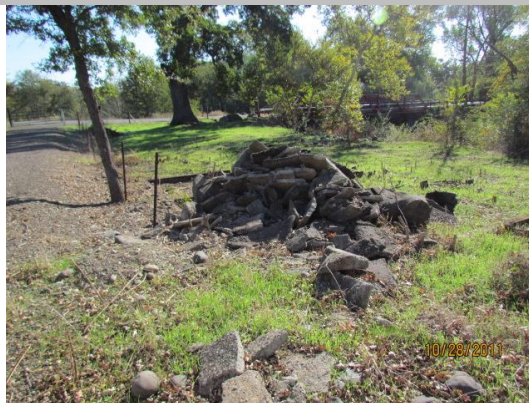
Photo 1 of 1 : SP\_2017\_NA0019\_79\_4\_20170315\_00003.jpg

LM Start	0.34	Rating **	M	Issue No.	4
LM End	0.34	Issue Type +	Ma	Location *	WS
Category	Earthen Levee			GPS Latitude/Longitude	
				Start	End
Item	Encroachments			39.970210 °	39.970210 °
				-122.015198 °	-122.015198 °
DWR ID	DWR_NA0019_02_s_2012_4				
Comment Code					
DE : Debris					
Inspector Comment

View of the concrete pile along the waterside toe.

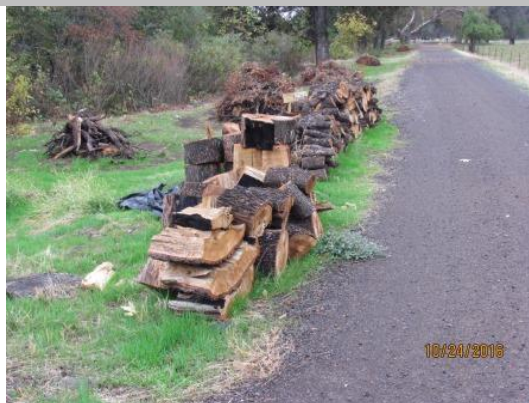
Photo 1 of 1 : SP\_2017\_NA0019\_79\_14\_20170315\_00008.jpg

LM Start	0.35	Rating **	M	Issue No.	14
LM End	0.35	Issue Type +	En	Location *	WS
Category	Earthen Levee			GPS Latitude/Longitude	
				Start	End
Item	Encroachments			39.970153 °	39.970153 °
				-122.015194 °	-122.015194 °
DWR ID	DWR_NA0019_02_f_2016_14				
Comment Code					
FW : Firewood					
Inspector Comment

View of the firewood along the waterside slope.

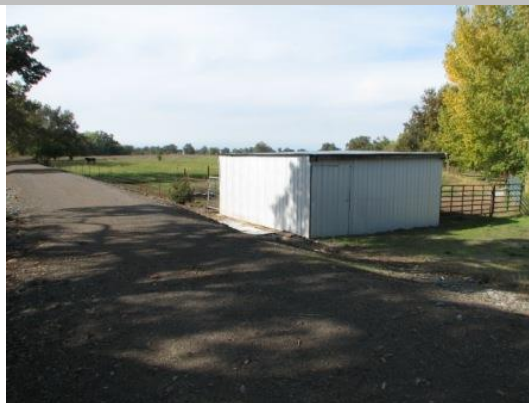
Photo 1 of 1 : SP\_2017\_NA0019\_79\_7\_20170315\_00005.jpg

LM Start	0.35	Rating **	M	Issue No.	7
LM End	0.35	Issue Type +	En	Location *	LS
Category	Earthen Levee			GPS Latitude/Longitude	
				Start	End
Item	Encroachments			39.970117 °	39.970117 °
				-122.015365 °	-122.015365 °
DWR ID	DWR_NA0019_02_s_2012_7				
Comment Code					
BU : Building					
Inspector Comment

View of a building along the levee toe.

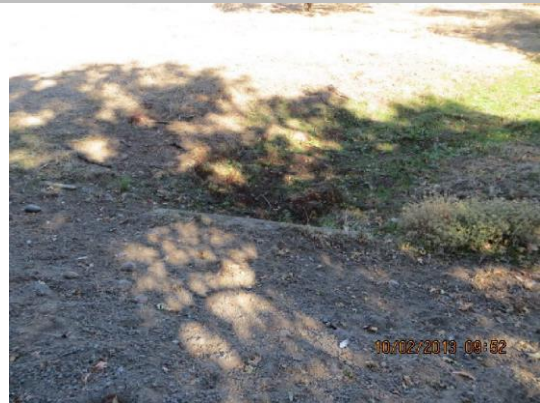
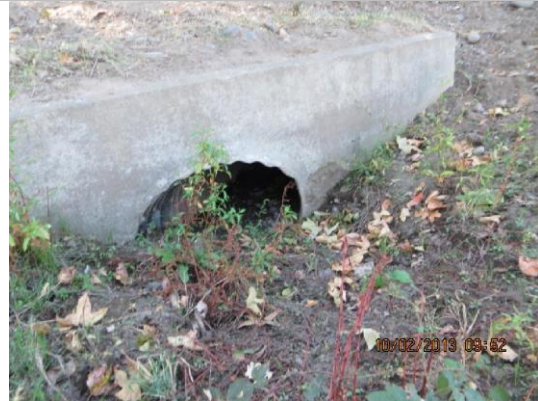
Comment Code					
Inspector Comment					
FS_ID:51442 DS_ID:20771 EP_NO: N/A Repair Type: Non-Urgent Crossing Status: Found UCIP Comments: 12/05/2016 Crossing has been downgraded from Urgent to Non-Urgent some debris blocking proper function of flapgate on WS. Recommend clearing debris from WS for flapgate to function properly. (O. Magana - DWR UCIP)10/01/2013 Debris blocking proper function of flapgate on WS toe. (W. Wylie - DWR UCIP) FIELD_STRUCT_DESC: 24-inch steel drainage pipe through the levee, 8.3 feet below the crown. Flap gate located on the waterside (WS) end. Concrete headwall located on the landside (LS). [Additional Reference(s): DWR Levee Log, 1992. USACE Sacramento O&M Manual Unit 509, March 1957, Unit 510, April 1963, Unit 511, May 1973, Unit 512, March 1964, Unit 513, December 1970, As-builts drawing 50-4-2394 (Station 155+40)]. FS Date: 12/5/2016

Concrete headwall at LS toe.

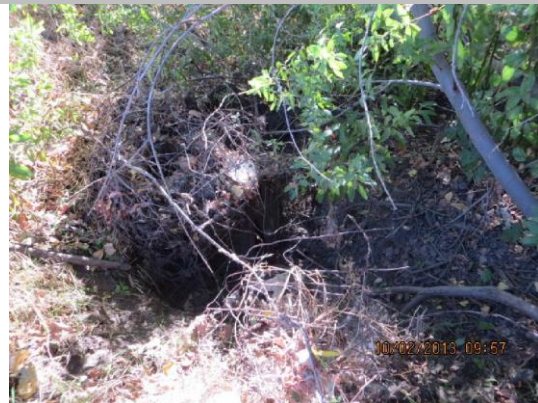
Photo 3 of 3 : UCIP\_SP\_2017\_51442\_36900.jpg

FS\_ID:51442  
DS\_ID:20771  
EP\_NO: N/A  
Repair Type: Non-Urgent  
Crossing Status: Found  
UCIP Comments: 12/05/2016 Crossing has been downgraded from Urgent to Non-Urgent some debris blocking proper function of flapgate on WS. Recommend clearing debris from WS for flapgate to function properly. (O. Magana - DWR UCIP)10/01/2013 Debris blocking proper function of flapgate on WS toe. (W. Wylie - DWR UCIP)  
FIELD\_STRUCT\_DESC: 24-inch steel drainage pipe through the levee, 8.3 feet below the crown. Flap gate located on the waterside (WS) end. Concrete headwall located on the landside (LS). [Additional Reference(s): DWR Levee Log, 1992. USACE Sacramento O&M Manual Unit 509, March 1957, Unit 510, April 1963, Unit 511, May 1973, Unit 512, March 1964, Unit 513, December 1970, As-builts drawing 50-4-2394 (Station 155+40)].  
FS Date: 12/5/2016

Outlet on WS toe.

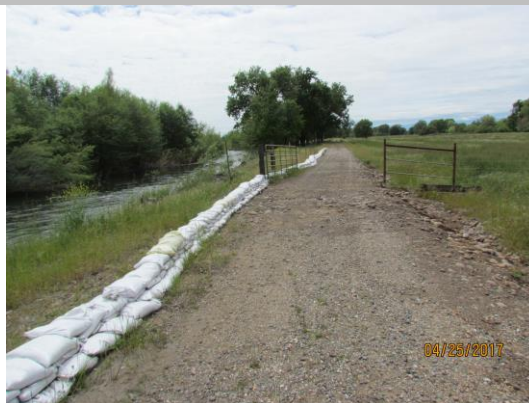
Photo 1 of 1 : SP\_2017\_NA0019\_79\_12\_20170505\_00015.jpg

LM Start	0.81	Rating **	M	Issue No.	12
LM End	0.85	Issue Type +	Ma	Location *	CR
Category	Earthen Levee			GPS Latitude/Longitude	
				Start	End
Item	Erosion / Bank Caving			39.968530 °	39.968248 °
				-122.023305 °	-122.023900 °
DWR ID	DWR_NA0019_02_s _ 2017_12				
Comment Code					
E2 : Schedule repair of erosion site prior to the next inspection.					
Inspector Comment					
Repair the crown roadway.

View of the erosion on the crown roadway.

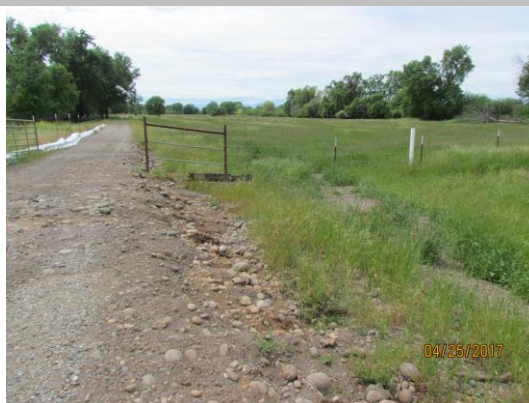
Photo 1 of 1 : SP\_2017\_NA0019\_79\_17\_20170505\_00016.jpg

LM Start	0.81	Rating **	M	Issue No.	17
LM End	0.85	Issue Type +	Ma	Location *	LS
Category	Earthen Levee			GPS Latitude/Longitude	
				Start	End
Item	Erosion / Bank Caving			39.968530 °	39.968248 °
				-122.023305 °	-122.023900 °
DWR ID	DWR_NA0019_02_s _ 2017_17				
Comment Code					
Inspector Comment					
Repair the erosion along the landside slope.

View of the erosion along the landside slope.

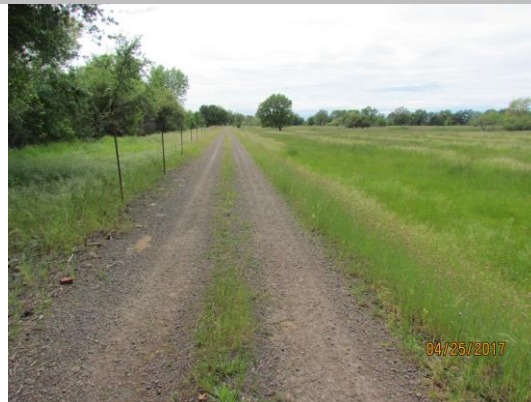
Photo 1 of 1 : SP\_2017\_NA0019\_79\_18\_20170505\_00017.jpg

LM Start	0.90	Rating **	A	Issue No.	18
LM End	0.90	Issue Type +	Ma	Location *	LS
Category	Earthen Levee			GPS Latitude/Longitude	
				Start	End
Item	Vegetation			39.967897 °	39.967897 °
				-122.024613 °	-122.024613 °
DWR ID	DWR_NA0019_02_s_2017_18				
Comment Code					
V1 : Control annual grass and weeds on the levee slopes and easements.					
Inspector Comment					
There are native grasses on both slopes.

View of native grasses on both slopes.

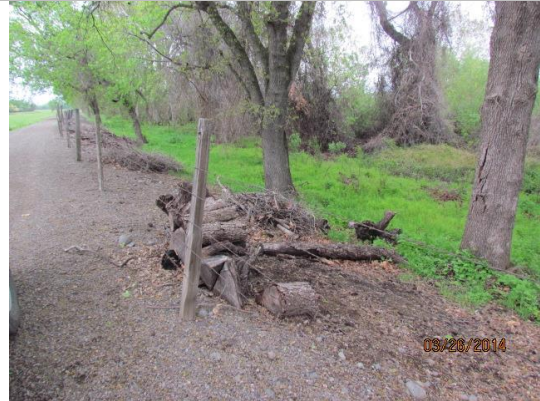
Photo 1 of 1 : SP\_2017\_NA0019\_79\_6\_20170315\_00004.jpg

LM Start	1.28	Rating **	M	Issue No.	6
LM End	1.28	Issue Type +	Ma	Location *	WS
Category	Earthen Levee			GPS Latitude/Longitude	
				Start	End
Item	Encroachments			39.964883 °	39.964883 °
				-122.030655 °	-122.030655 °
DWR ID	DWR_NA0019_02_s_2012_6				
Comment Code					
FW : Firewood					
Inspector Comment

View of the firewood along the waterside slope.

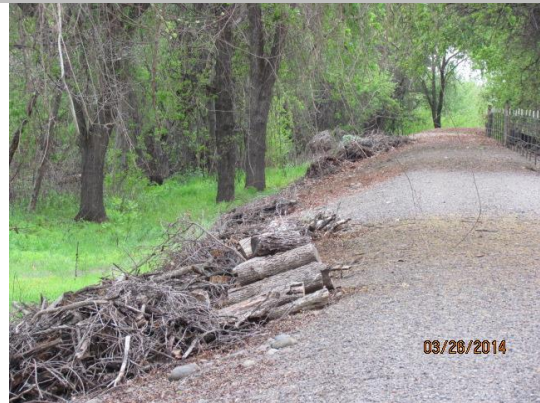
Photo 1 of 1 : SP\_2017\_NA0019\_79\_3\_20170315\_00002.jpg

LM Start	1.37	Rating **	M	Issue No.	3
LM End	1.37	Issue Type +	En	Location *	WS
Category	Earthen Levee			GPS Latitude/Longitude	
				Start	End
Item	Encroachments			39.963997 °	39.963997 °
				-122.032030 °	-122.032030 °
DWR ID	DWR_NA0019_02_f_2013_3				
Comment Code					
DE : Debris					
Inspector Comment

View of the debris along the waterside slope.

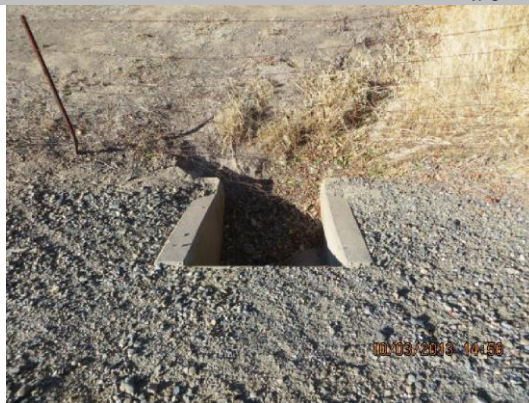
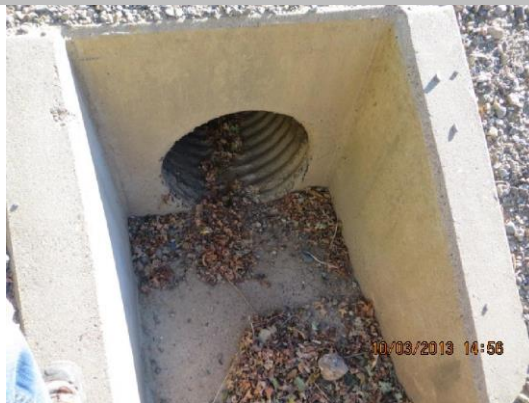
LM Start	0.25	Rating **	A/W	Issue No.	917
LM End	0.25	Issue Type +	Ma	Location *	LS
Category	Supplemental			GPS Latitude/Longitude	
				Start	End
Item	DWR UCIP LMA Responsibility			40.051604 °	40.051604 °
				-122.184431 °	-122.184431 °
DWR ID					
Comment Code					
Inspector Comment					
FS_ID:21795					
DS_ID:20775					
EP_NO: N/A					
Repair Type: No Action Needed					
Crossing Status: Found					
UCIP Comments:					
FIELD_STRUCT_DESC: 24-inch CM drain pipe through levee, 4-feet below crown. Flap gate and concrete "U" headwall on waterward end. Concrete "U" headwall on landward end. Originally included in USACE O+M manual (1963). As-built drawing No. 50-4-3622.					
FS Date: 10/3/2013

Concrete U-shaped headwall on LS toe.

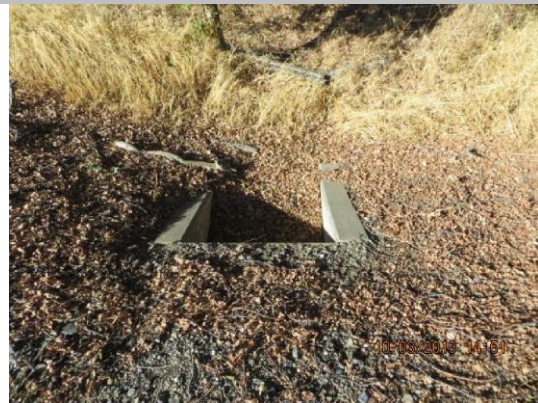
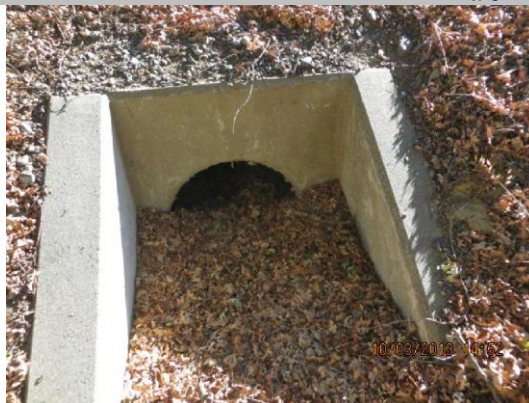
LM Start	0.38	Rating **	A/W	Issue No.	918
LM End	0.38	Issue Type +	Ma	Location *	LS
Category	Supplemental			GPS Latitude/Longitude	
				Start	End
Item	DWR UCIP LMA Responsibility			40.051572 °	40.051572 °
				-122.182093 °	-122.182093 °
DWR ID					
Comment Code					
Inspector Comment					
FS_ID:22826					
DS_ID:20776					
EP_NO: N/A					
Repair Type: No Action Needed					
Crossing Status: Found					
UCIP Comments:					
FIELD_STRUCT_DESC: 24-inch CM drain pipe through levee, 4.5 feet below crown. Flap gate and concrete "U" headwall on waterward end. Concrete "U" headwall on landward end. Originally included in USACE O+M manual (1963). As-built drawing No. 50-4-3622.					
FS Date: 10/3/2013

Concrete U-shaped headwall on LS toe.
